Field Service Bulletin

Document Number: 1FB-00006-0000

Product: 2151
Supersedes: None
Date: 06/26/2014
___Enhancements

POTENTIAL TOUCHSCREEN DISCOLORATION ON 2151 PHONE

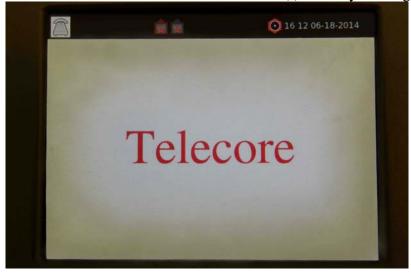
A small quantity of 2151 phones manufactured prior to 01-21-2013, have been found to have yellowing discoloration of the touchscreen. Yellowing discoloration of the touchscreen was discovered on a few units in Telecore's Lab. The yellowing discoloration may be caused by the use environment or other environmental testing which was performed on our lab units, so may or may not be present in any fielded units. As a precaution, Telecore is informing customers of the potential for the touchscreen yellowing discoloration. Based on our lab usage of the phones, it's also possible that the yellowing discoloration was brought on by extended periods of time in which the LCD backlight display is ON and set to FULL brightness. Therefore, as a secondary precaution, Telecore is recommending that users NOT configure the backlight timer to 00:00 which disables the LCD backlight from turning off, and creates the "always ON" condition. It's believed that the yellow discoloration only exists in a single lot of touchscreens. The suspect lot of touchscreens was purchased on/around April of 2009. The picture below can be used to determine if the 2151 unit(s) has the yellowing discoloration.

Units which exhibit the yellowing/discoloration of the touchscreen can be returned to Telecore for repair at no cost. To facilitate proper tracking, return and repair of any units with this issue, please request a RMA number through Telecore's website www.telecore.com, and follow standard RMA procedures. Only units which are verified by Telecore to have this issue will be repaired at no cost.
