**Document Number: 1FB-00007-0000**

**Product: TXP-A**

### **POTENTIAL TOUCHSCREEN DISCOLORATION ON TXP-A PHONE**

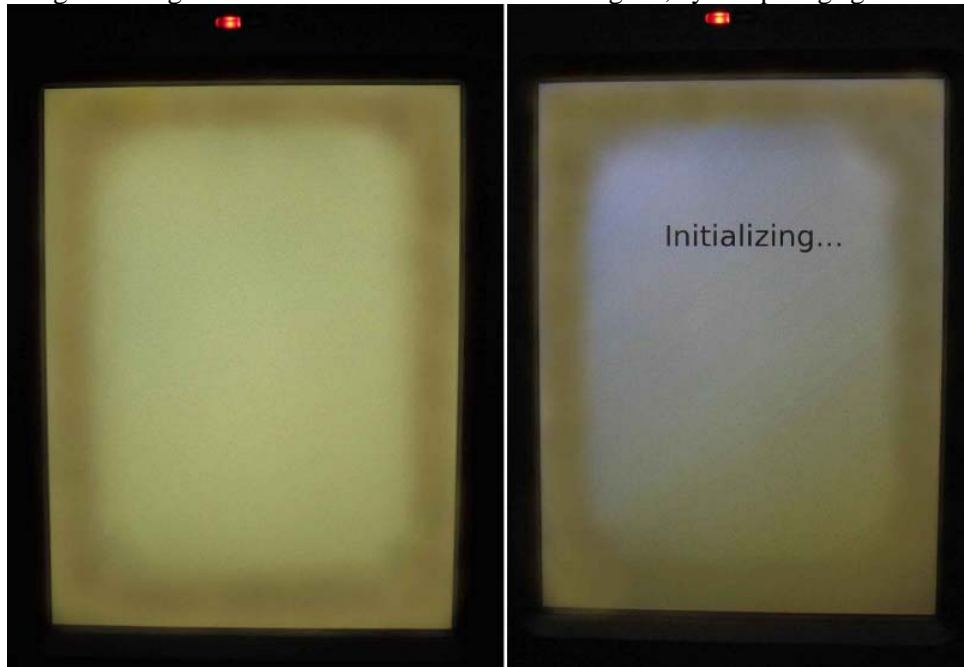
A small quantity of TXP-A phones manufactured and shipped prior to 08-26-2013, are suspect to have yellowing/browning discoloration of the touchscreen/EMI glass. Yellowing/browning discoloration of the touchscreen/EMI glass was discovered in a few units in Telecore's Lab. The yellowing/browning discoloration may be caused by the use environment or other additional environmental testing which was performed on our lab units, so may or may not be present in any fielded units. The yellowing/browning doesn't affect the functionality of the unit. As a precaution, Telecore is informing customers of the potential for the touchscreen yellowing/browning discoloration. It's believed that the yellow discoloration exists primarily in an early lot of touchscreen/EMI glass parts. The suspect lot of touchscreen/EMI glass parts was purchased in late 2009. You can determine if your TXP-A unit has the yellowing/browning discoloration of the touchscreen/EMI glass, by comparing against the pictures below.

The yellowing/browning is cosmetic and does not affect the functionality of the unit. As such, customers are not required to send the units back for upgrade. Units which exhibit the yellowing/browning discoloration of the touchscreen/EMI glass can be returned to Telecore for repair. To facilitate proper tracking, return and repair of any units with this issue, please request a RMA number through Telecore's website [www.telecore.com](http://www.telecore.com), and follow standard RMA procedures. As determined by Telecore personnel, units which are received with other failures along with the yellowing/browning discoloration will be handled as a standard RMA.
